# Confidential Inspection Report

CHERRY VALLEY, CA 92223

Inspector, Robert Gutierrez NACHI22041116  
New Horizons Home Inspection LLC

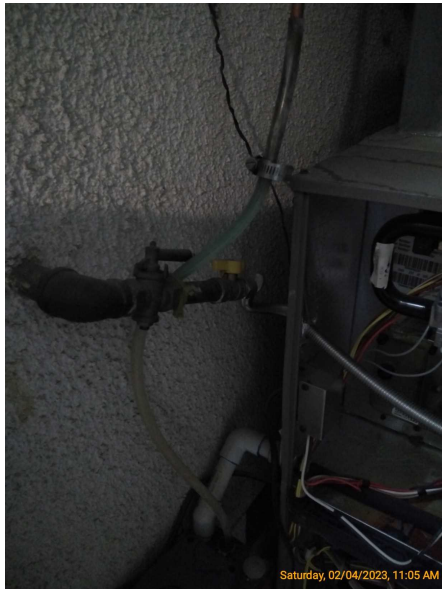
## **GAS SUPPLY**

The gas piping includes a 90 degree shutoff valve for emergency use. The valve was not tested at the time of inspection. This age and style of valve is normally found to be operable by hand and generally trouble free.

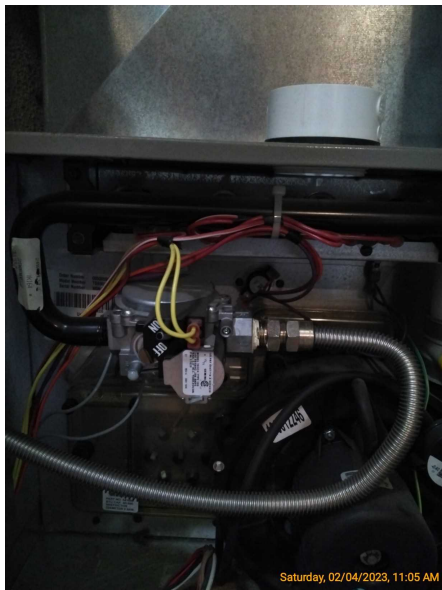
## **REGULATOR & CONTROL**

The gas pressure regulator and control valve appear to be properly installed and in serviceable condition.

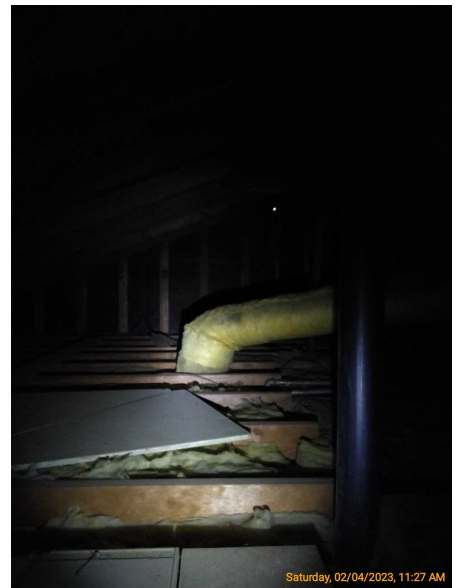
## DUCT INSULATION

The ducts are insulated with fiberglass. The insulation appears to be properly installed and in good condition.

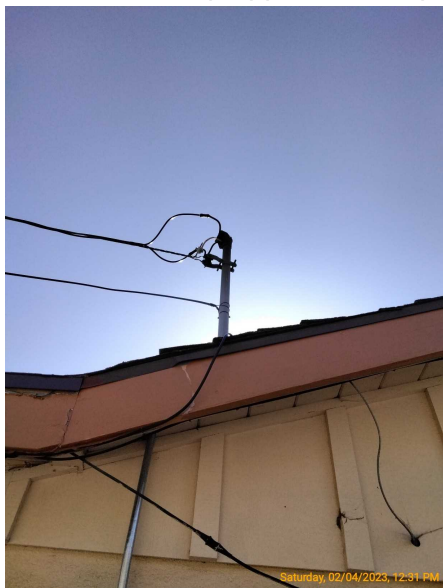
## SERVICE DROP

The service drop appears to be properly installed and in good condition.

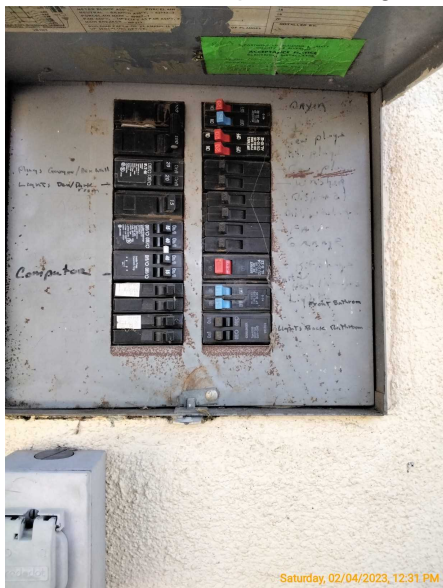
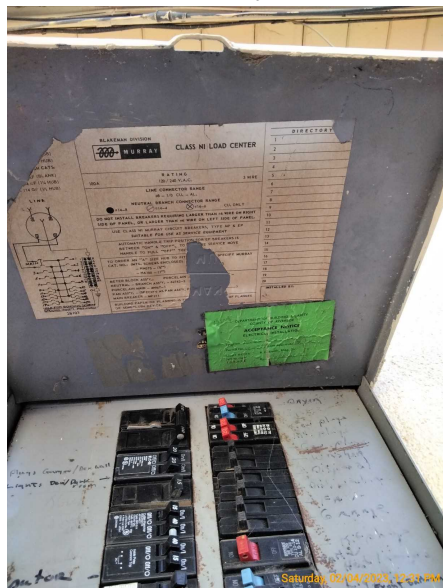
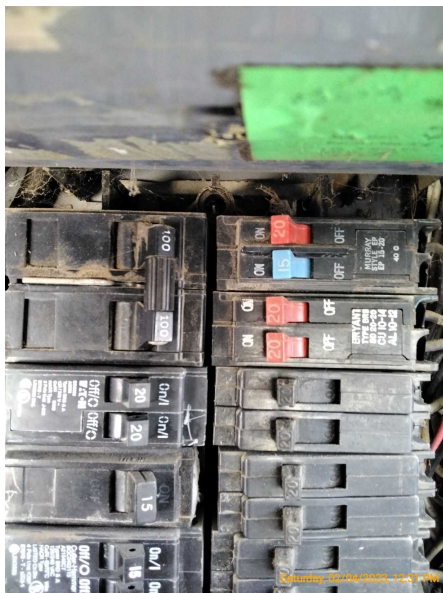
## CB MAIN PANEL

The main service panel is in good condition with circuitry installed and fused correctly.

The circuitry is not completely labeled. We recommend that each circuit be identified, allowing individuals unfamiliar with the equipment to properly operate it when and if necessary.

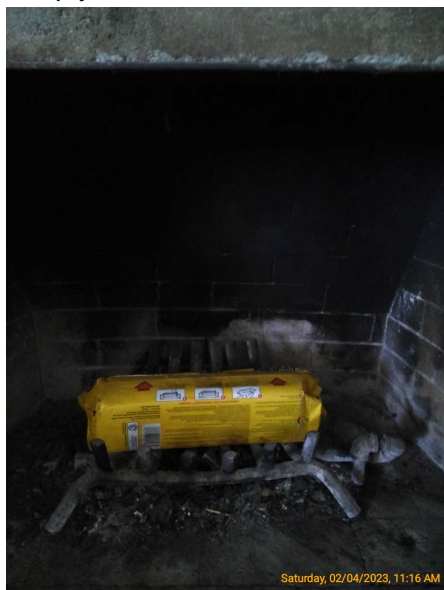
Minor cracks and/or erosion are normal and should not be a concern unless or until the bricks become deeply eroded or loose.

We were not able to fully evaluate the fireplace and chimney because of the build-up of soot and/or creosote. We recommend the flue be cleaned and that further inspection be accomplished prior to the close of escrow.

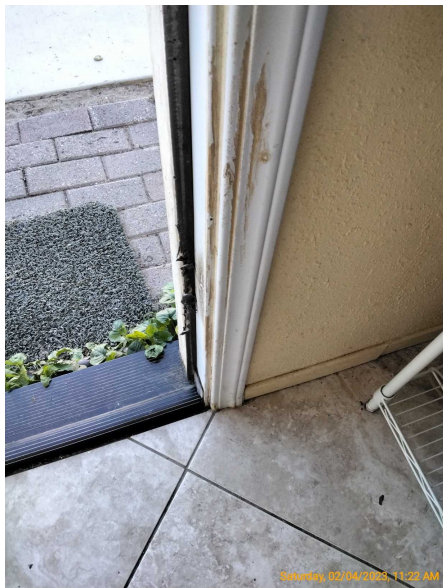
The weatherstripping is generally in poor condition and will not be effective. To conserve energy and lower the utility bills, we recommend all deficient weatherstripping be repaired or replaced.

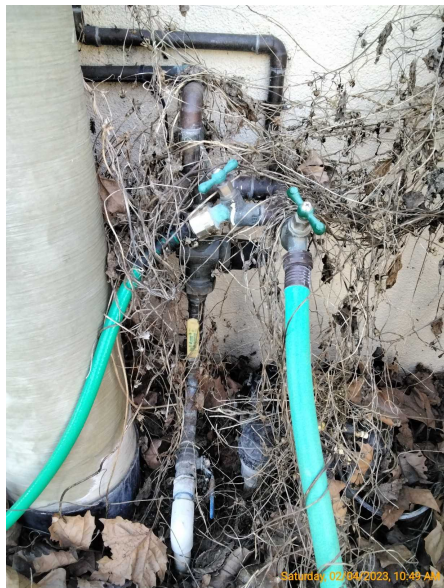
### **WATER SHUTOFF LOCATION**

The domestic water supply main shut-off valve is outside at the northwest corner of the building.

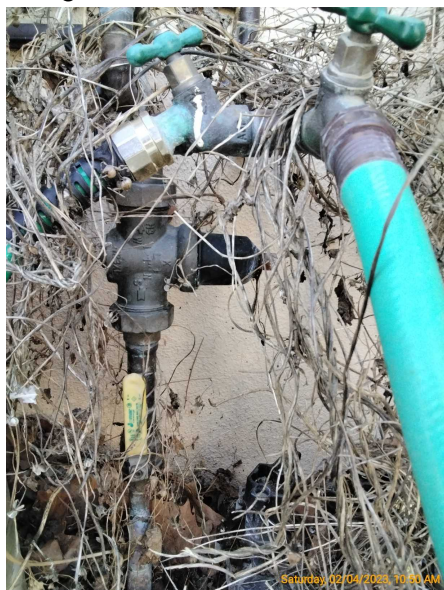
## REGULATOR

There is a regulator installed near the main shut off to maintain water pressure at an acceptable level in an area where pressure is generally higher than normal. The pressure regulator is functioning as designed.

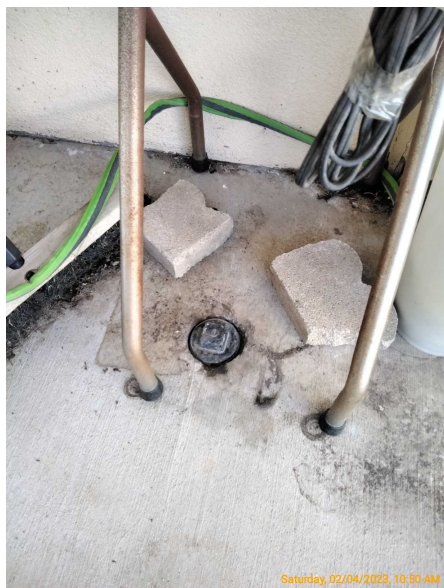
## SEWER CLEANOUT

The sewer cleanout is located at the rear of the structure.

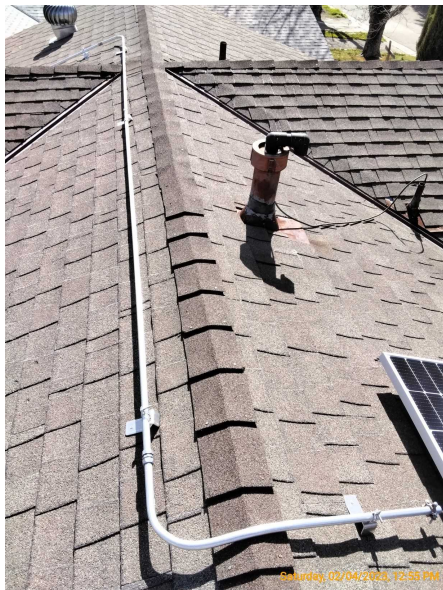
## APPLIANCE VENTS

The appliance vents appear to be properly installed and in serviceable condition.

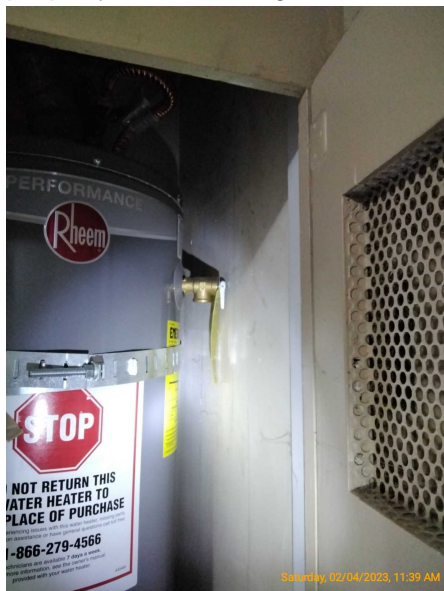
### T/P RELEASE VALVE

The water heater is equipped with a temperature and pressure relief valve, however it is not installed properly or it discharges to an unapproved location. We recommend it be repaired and properly installed.

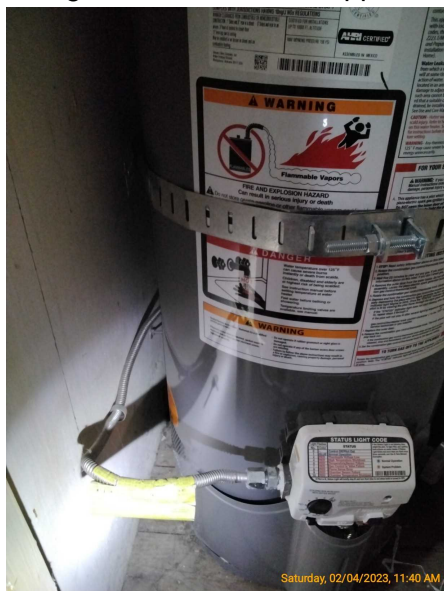
### GAS SUPPLY

The gas piping for the appliance includes a local 90 degree shut-off valve for use in an emergency or in case of repair. The valve was not tested at the time of inspection, but is of a type usually found to be serviceable.

The gas connector is an approved flexible type in good condition.

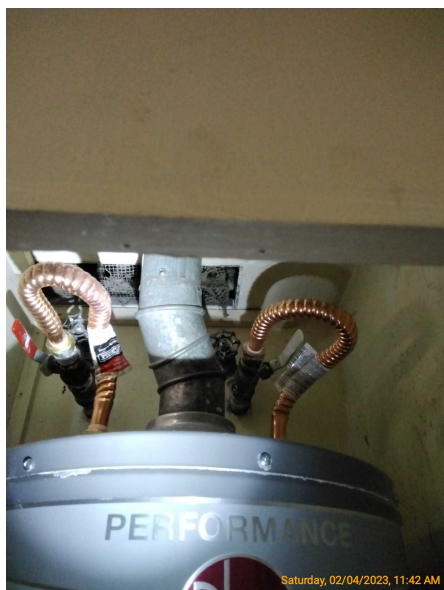
## WATER CONNECTORS

The cold water inlet and hot water outlet connections appear properly installed and in serviceable condition.

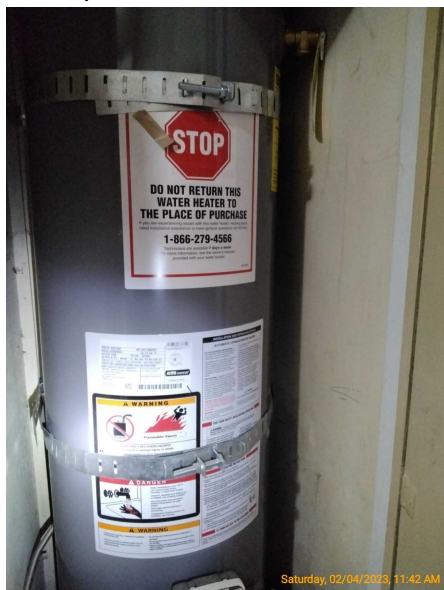
## SEISMIC RESTRAINT

The water heater tank has been secured. This feature will help prevent water heater movement and possible gas leakage, limit damage and provide a source of usable domestic water in the event of a major earthquake.

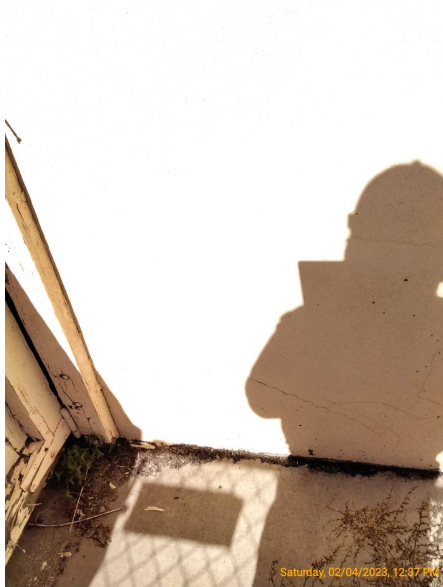
## STUCCO

The stucco exterior is in good condition, with a few minor cracks. These hairline cracks are typical and no action is indicated. They can be patched and sealed in the course of routine maintenance.

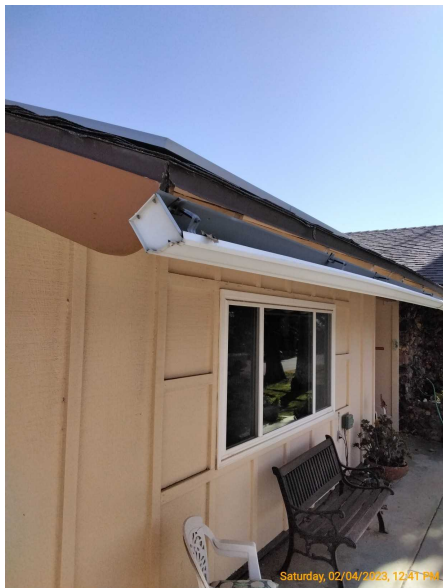
## GUTTERS

Several sections of the gutters are damaged. We recommend repair or replacement.

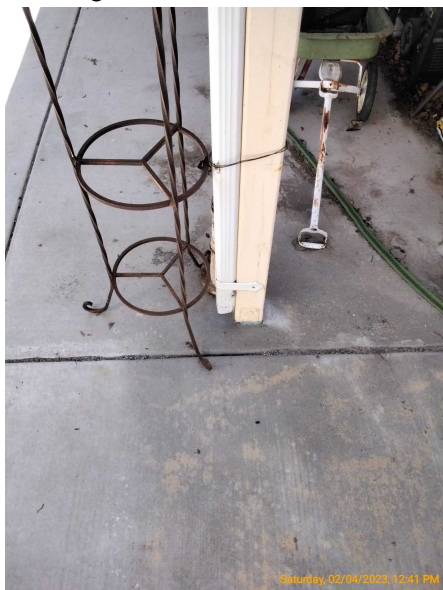
## DOWNSPOUTS

The downspouts appear to be properly installed and in serviceable condition, with exceptions noted below.

Missing elbow

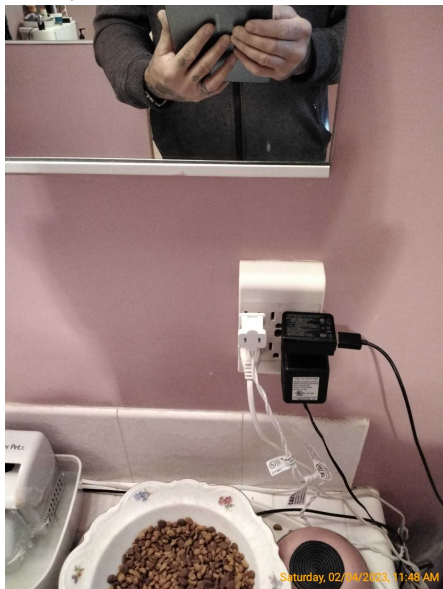
## RECEPTACLES

There is no GFCI (ground fault circuit interrupter) protection for this bathroom. For an increased margin of safety, we recommend the installation of a GFCI receptacle.

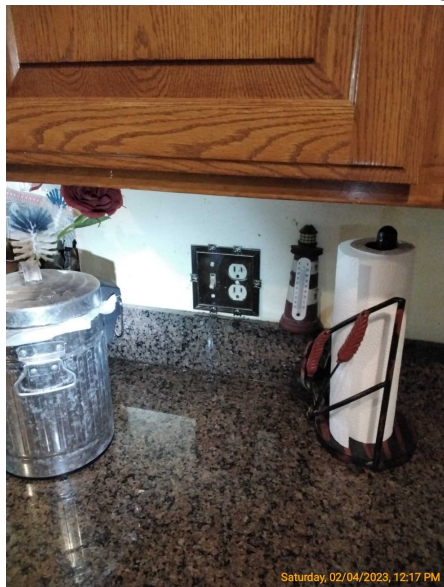
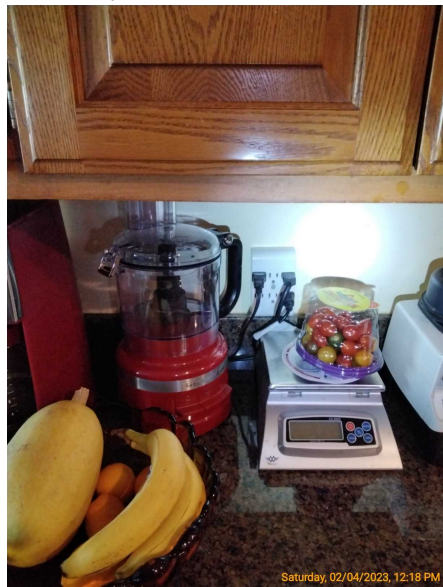
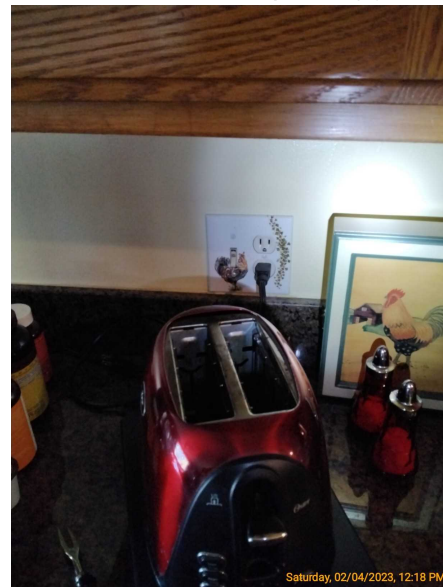
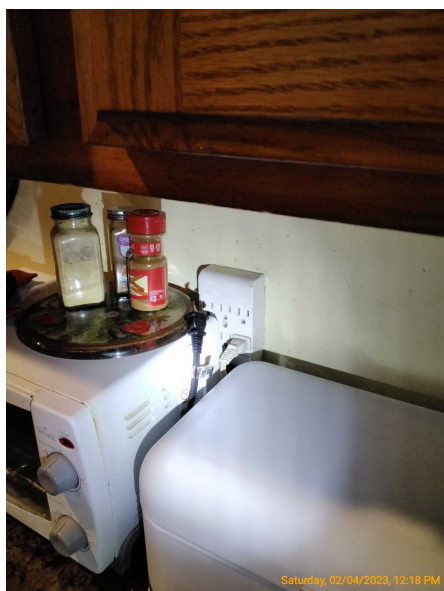
## RECEPTACLES

There is no GFCI (ground fault circuit interrupter) protection for the countertop receptacle(s) within six feet of the sink. For an increased margin of safety, we recommend the installation of a GFCI receptacle(s).

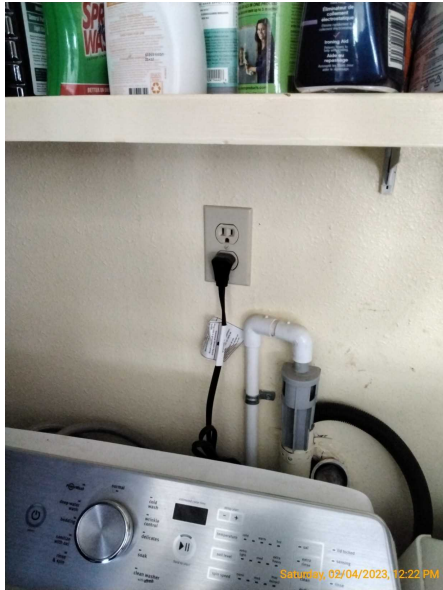
### **RECEPTACLES**

There is no GFCI (ground fault circuit interrupter) protection for this area. For an increased margin of safety, we recommend the installation of a GFCI receptacle.
